WETLAND DELINEATION REPORT

SOMERSET COUNTY EXPANSION PROJECT SOMERSET COUNTY, MARYLAND

GTA Project No: 31191824

Re: Wetland Delineation Report
Somerset County Expansion Project
Somerset County, Maryland

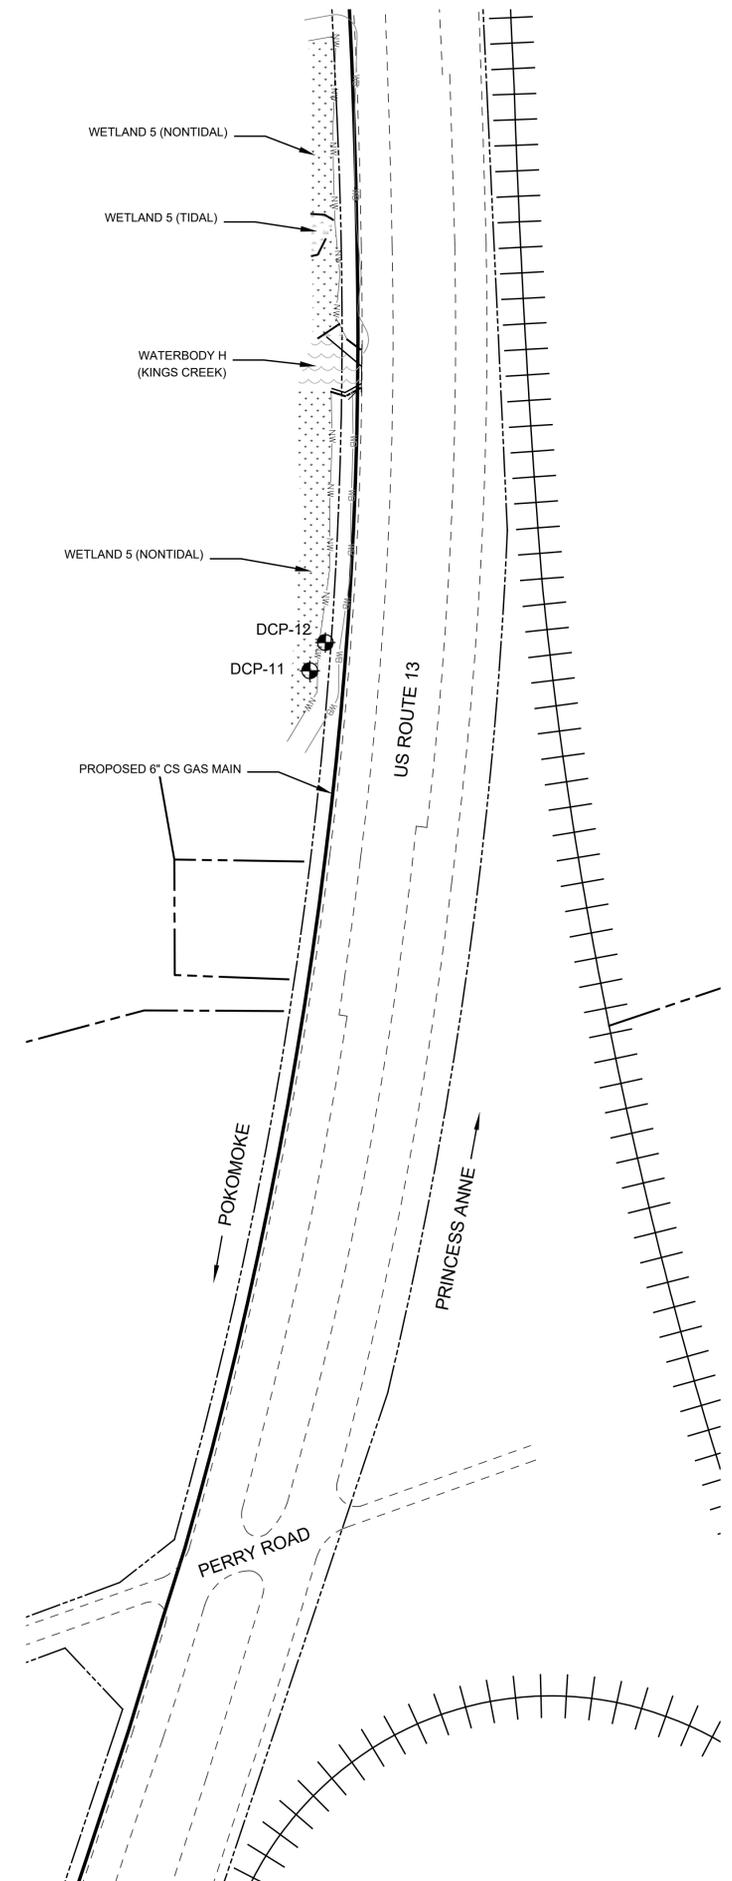
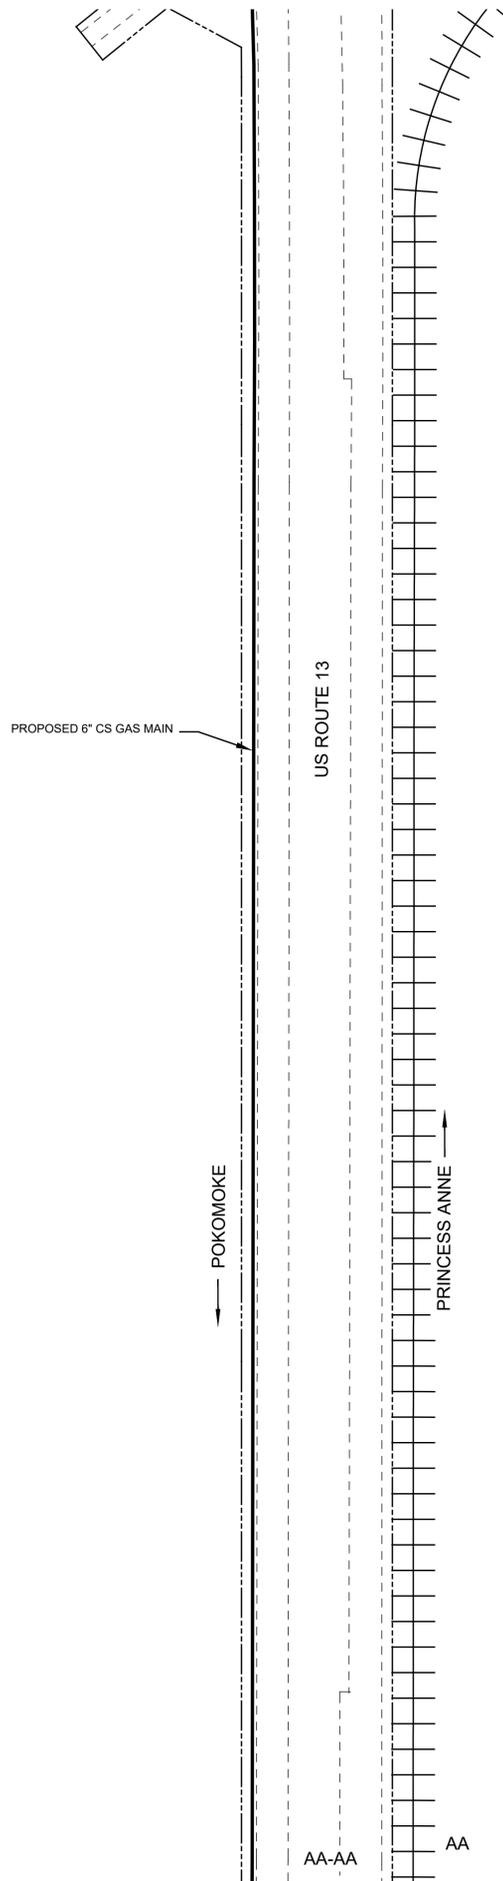
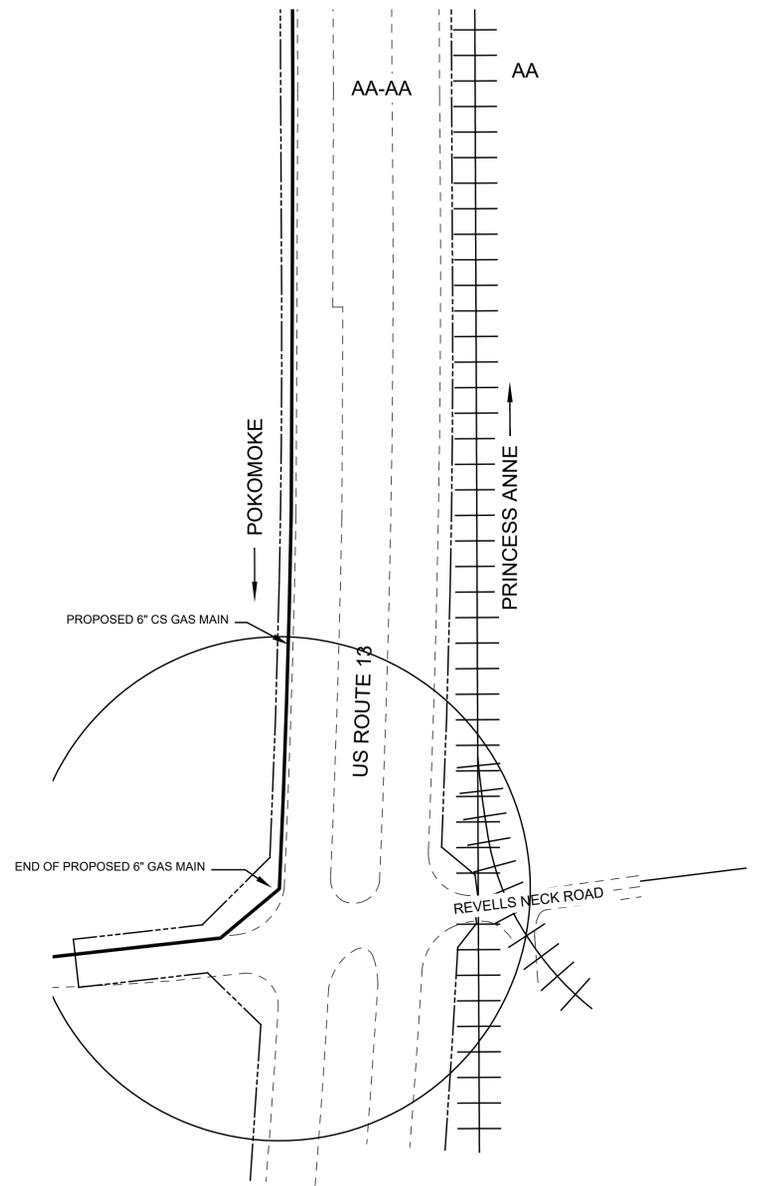
NOTE:
 PROPOSED 6" CS GAS MAIN -
 TO BE INSTALLED IN THE GRASS SHOULDER
 APPROXIMATELY 5 FEET OFF THE EDGE OF
 PAVEMENT AND AT A MINIMUM DEPTH OF 5 FEET
